**State of Louisiana
Coastal Protection and Restoration Authority**

2017 Annual Inspection Report

**Barataria Barrier Island Complex
Project: Pelican Island and Pass La Mer
to Chaland Pass Restoration**

State Project Number BA-38
Priority Project List 11

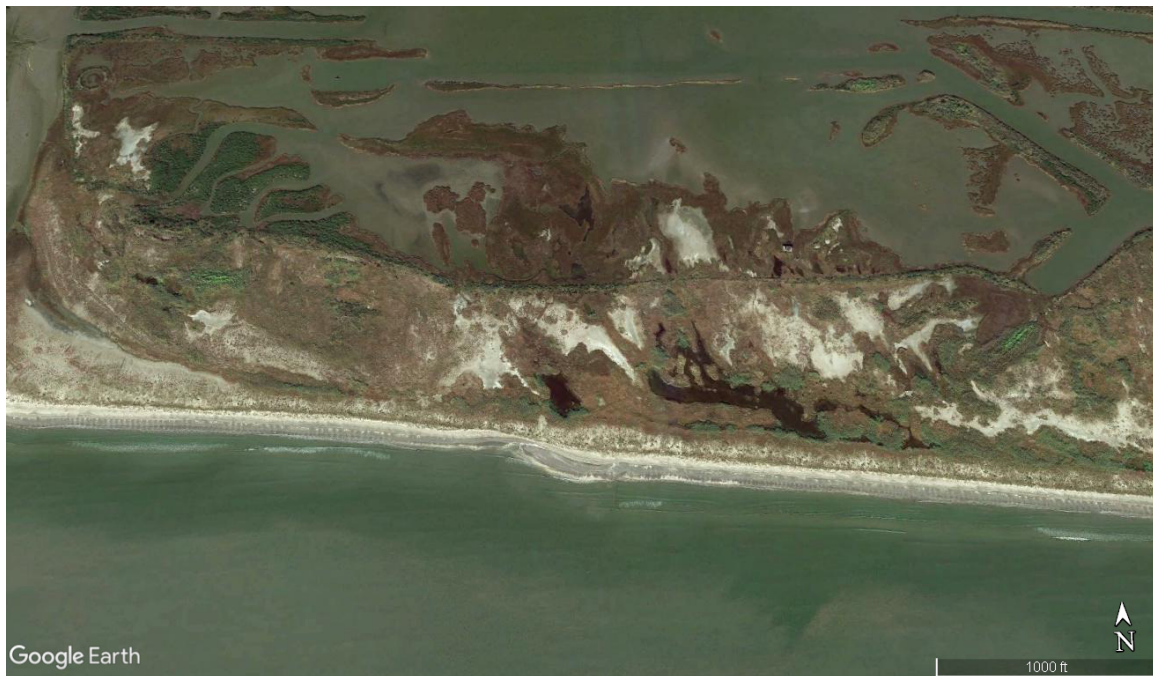
Photo #2 – Chaland Headland West Side.

The dike on the Chaland Headland segment of the project appears to be subsiding and degrading slowly. There are some breaches where water can flow freely between the surrounding marsh and the project area. The western portion of the area shows some ponding in the scour locations from the storm events seen over the years. These ponds are not connected to anything but may get flushed during high tide events.

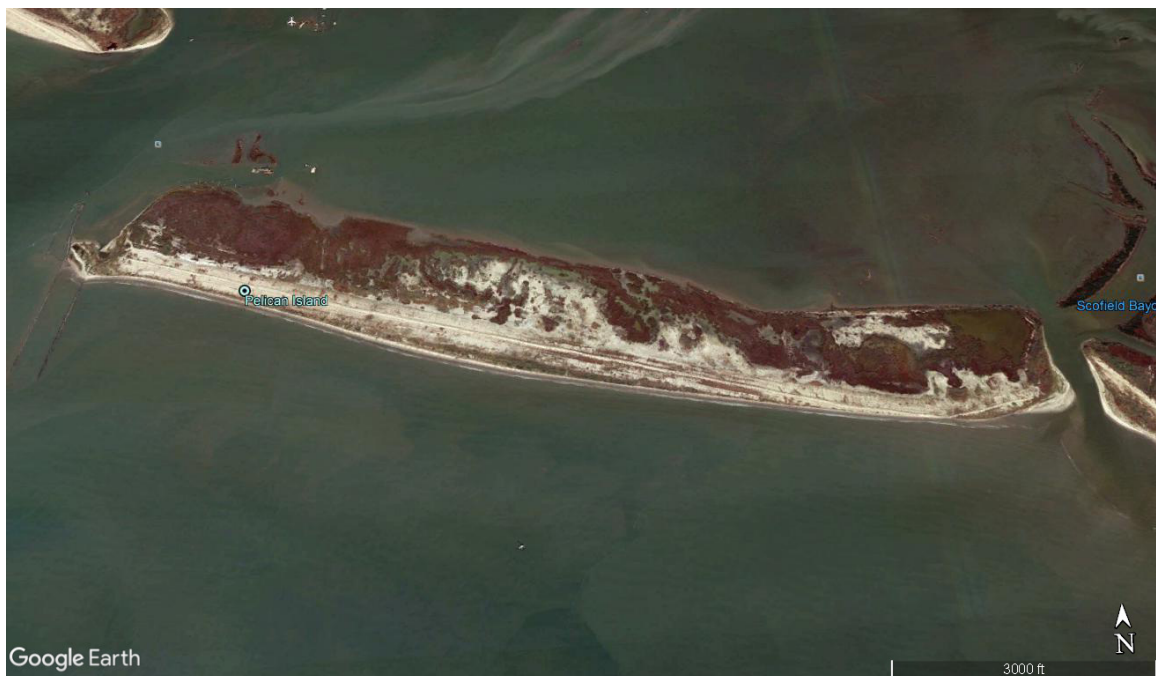
Photo #4 – Pelican Island Full Area.

The dike on the Pelican Island segment has degraded and water is flowing freely into the marsh platform. This is also causing some erosion into the marsh platform.
